TITLE: Oak Bay Park Sand Lance Habitat Restoration			NUMBER: 09-1659P (Planning/Acquisition)		
			STATUS: Preapplication		
APPLICANT: Jefferson County MRC			CONTACT: Gabrielle LaRoche (360) 531-2458		
COSTS:			SPONSOR MATCH:		
	RCO	\$119,745		100 %	
	Local	\$0		0 %	
	Total	\$119,745		100 %

Site Plan, Existing Conditions

Oak Bay County Park Restoration Feasibility & Design Jefferson County, WA

Introduction

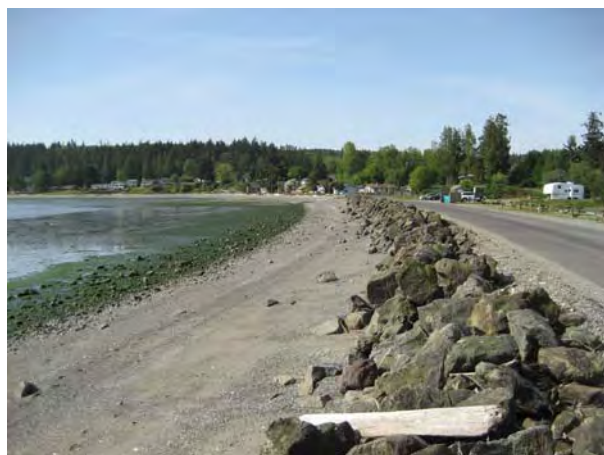
Shoreline armoring looking southwest, note angular rock low on the beach at left.

The CGS Survey mapped several features identified for removal: The rock shoreline armoring, scattered rock low on the upper beach, boat ramp, road on the south spit, and camping sites. The shoreline armoring, consisting of 2–3 ft angular, stacked rock, covered a total length of 1,110 ft alongshore for a total aerial coverage of 12,100 ft². The depth of rock is unknown, as no excavation was made during the site survey, and no as-built plans are known to exist. Many small (12" and less), angular rocks were seen scattered low on the upper beach, partially covering 14,800 ft² of intertidal area. These rocks were likely tumbled from the larger rock armoring during high-water storm events. The boat ramp, consisting of mostly broken concrete slab, covered 588 ft² of upper beach. Much of the lower section of concrete has been broken up and scattered by wave action. The road and compacted shoulder area immediately landward of the rock covered 35,800 ft², while the camp sites covered 32,400 ft².

Figure 2. Site photographs showing the spit, shoreline armoring, and boat ramp at the park. Top photos taken 5/18/07, middle and bottom taken 3/16/09.

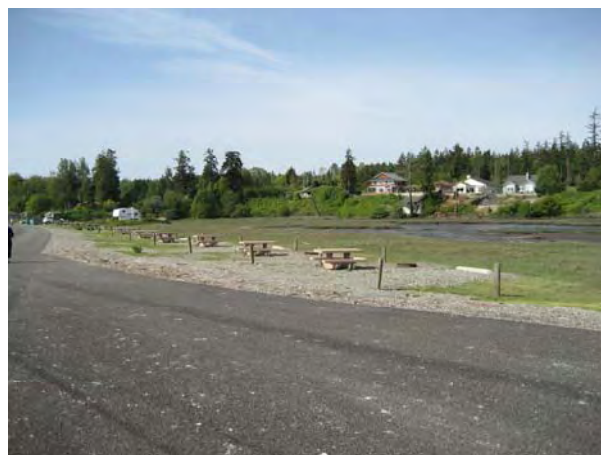
Camping sites (now decommissioned) at the eastern end of the Park spit.

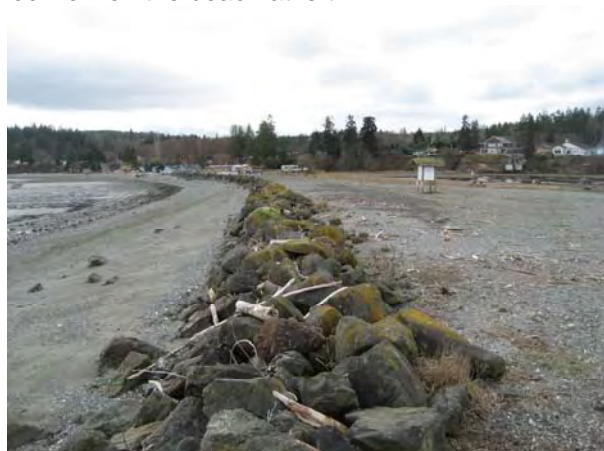
Shoreline armoring looking southwest near the end of the Park.

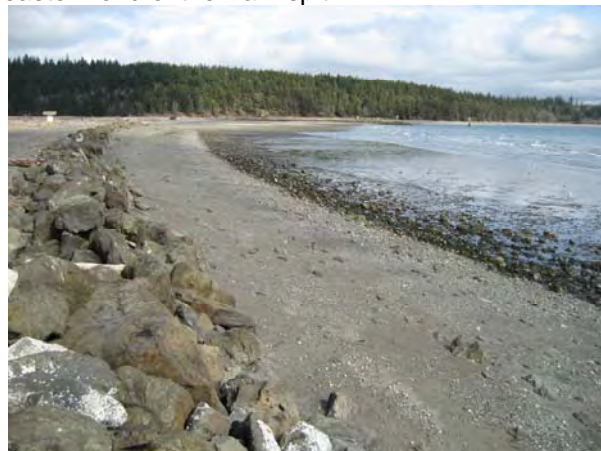
Shoreline armoring looking northeast, note angular rock low on the beach at right.

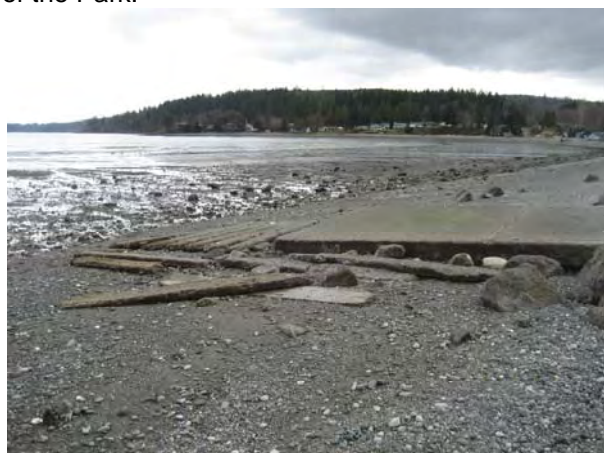
Lower end of boat ramp at the Park

(1973). The results showed that the existing inlet “is marginally stable and may be subject to periodic closures under existing conditions”. Additionally, PWA reported that the boat ramp acts as a groin, which limits wave-induced sediment transport into the inlet, permitting the inlet to remain open. In full agreement with CGS qualitative analysis, if the rock revetment and boatramp were simply removed, the likely result would be accelerated inlet closure.

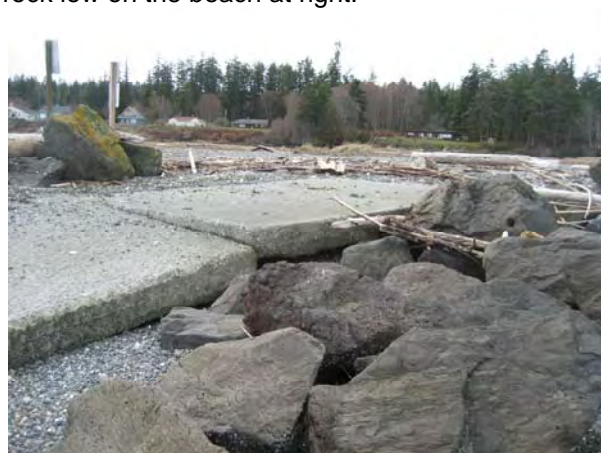
Upper end of boat ramp at the Park

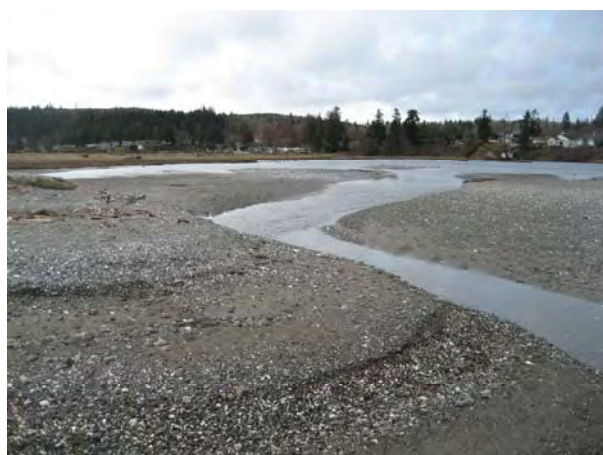
Tidal inlet looking into lagoon at low tide

The present inlet opened in a storm in December 2003 (Todd et al. 2006, Latham pers. comm.). Prior to that, a very small and intermittently open inlet was present along the west edge of the west jetty (USACE 2003, Latham pers. comm.). With both inlet locations, the result of net shore-drift along the Park shoreline has been the transport of a large quantity of sediment to the inlet, which tends to get transported into the inlet by the prevailing southerly wind waves. The flood tide also tends to bring more sediment into the inlet, which is then deposited on the flood tidal delta, just inside the lagoon. While the subsequent ebb tide does transport some of the sediment back out of the lagoon, the likely net impact of flood and wind wave transport has been infilling of the flood delta.

Figure 3. Site photographs showing the tidal inlet and lagoon, taken 3/16-17/09.

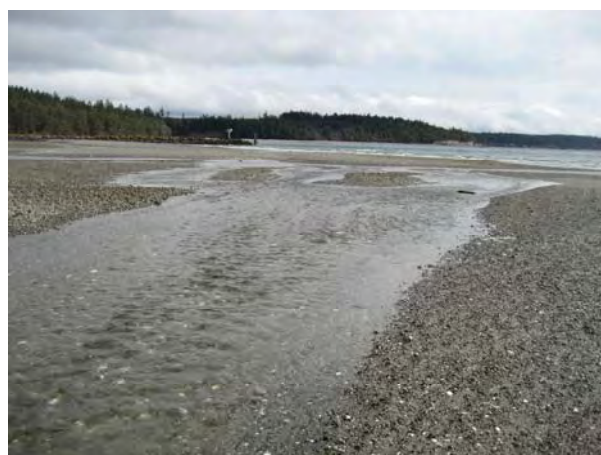
Tidal inlet looking toward Oak Bay at low tide

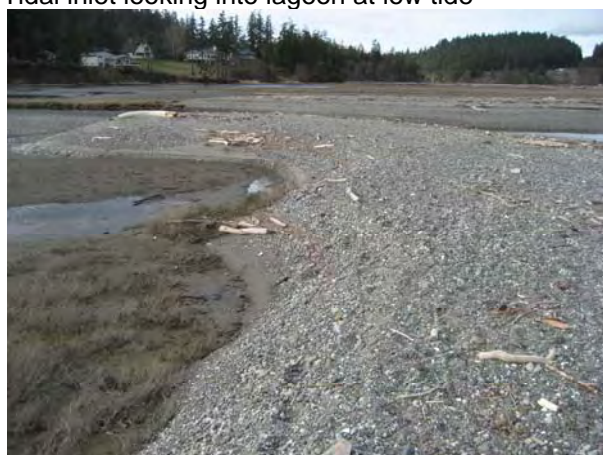
Spit on western side of tidal inlet

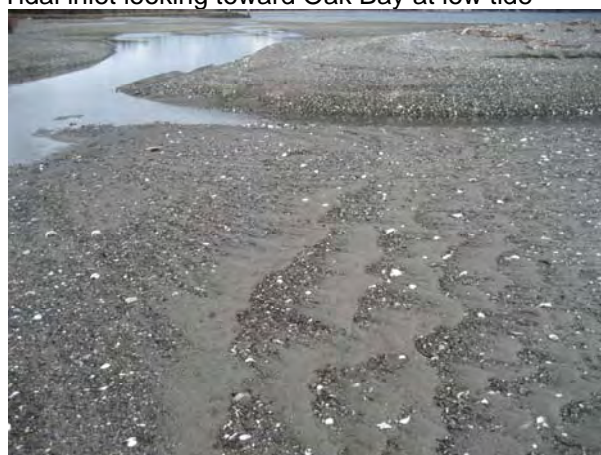
Sand dune forms on flood delta, likely formed by wave action entering the lagoon at high tide

LiDAR data from early 2002 obtained from the Puget Sound LiDAR Consortium (LiDAR 2002) was compared with CGS ground survey data from 2009 to help determine the rate of change within the flood tidal delta (FTD) inside the lagoon. The LiDAR was captured at a time when water levels within the lagoon were at approximately +8 ft MLLW, and was unable to penetrate the water surface. An estimate of the water depth was made using the 2009 survey as a guide. A handful of new points were then created for the LiDAR surface at the estimated elevations in an area surrounding the current flood delta, which were limited to the northwest side of the FTD.

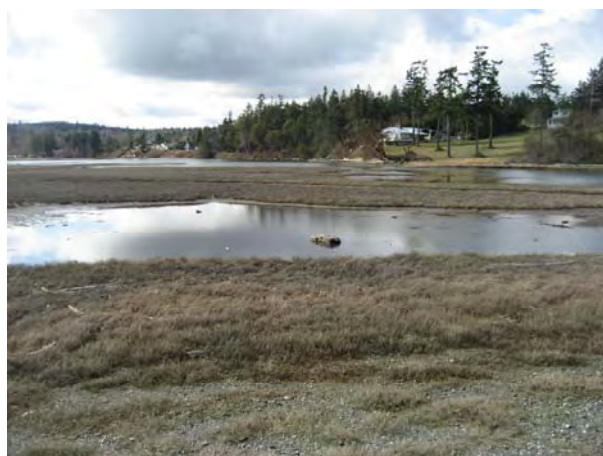
Northeastern portion of lagoon looking west

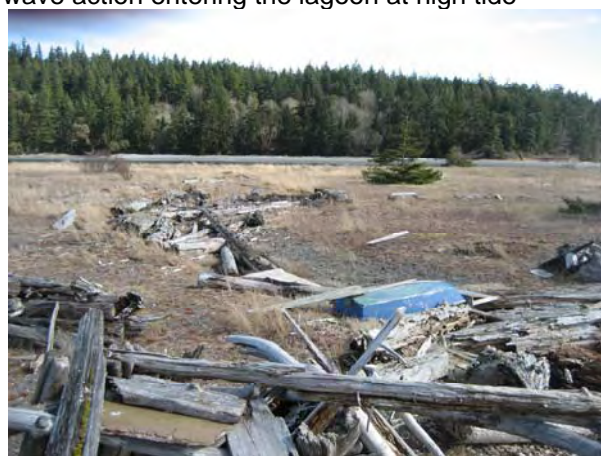
Possible location of new inlet discussed in Alternative 4, note low-lying area filled with wood debris.

Alternative Inlet locations 1 and 2 are very similar to the conceptual alternatives forwarded by the USACE (2003) in a preliminary report. Both involve the complete removal of shoreline armoring at the park along with the boat ramp. The current tidal inlet would be closed off and a new tidal inlet would be created on the eastern side of the lagoon. The location of the new channel is the only variable between these two alternatives. Alternative Inlet Location 1 is on the shore of the Port Townsend Ship Channel, just north of the west jetty. Alternative Inlet Location 2 is also on the shore of the Ship Channel, but further north (Figure 9). The 2 alternative channels would be 900–1,300 ft long. Both of these alternatives would have essentially the same effect on the physical condition of the lagoon and water levels in general, as they

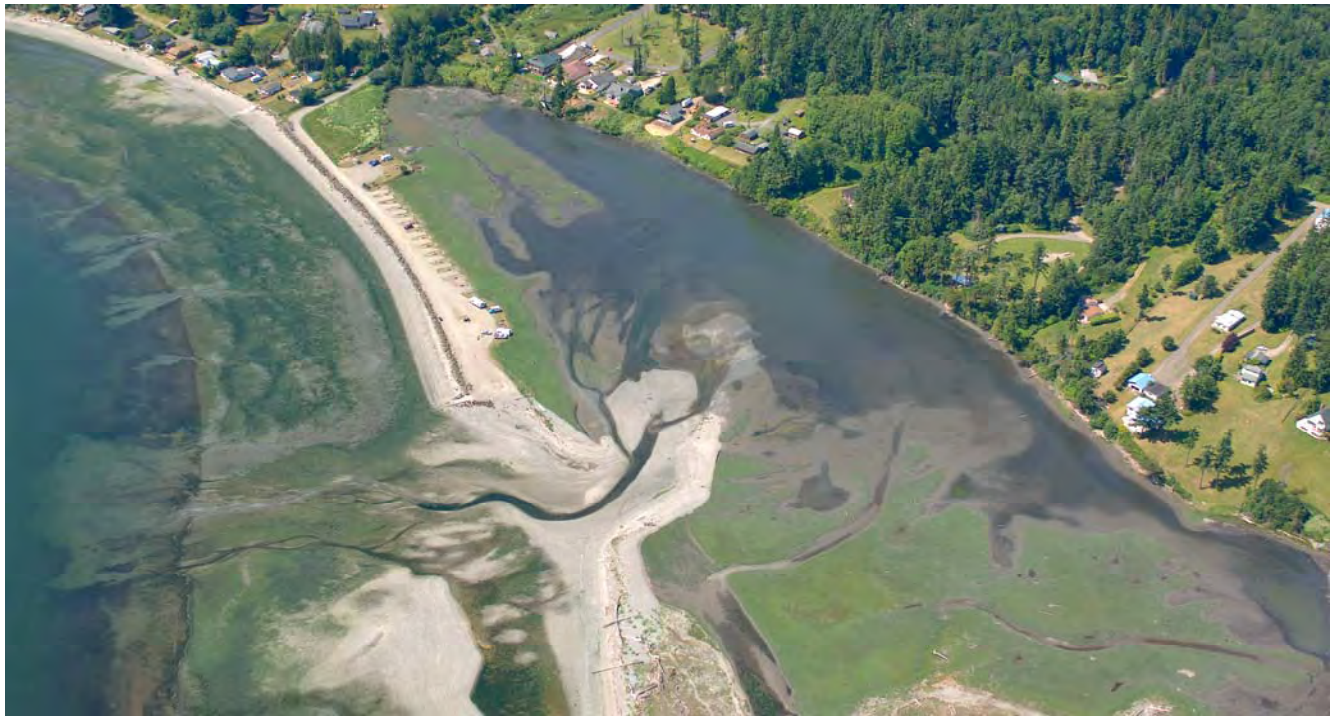
Figure 4. Oblique aerial photo looking southwest at Oak Bay County Park, taken 6/23/2006 for WA DOE.

The Park consists of the mostly decommissioned spit campsites and a much larger upland campsite and surrounding area on the north shore of the lagoon (Figures 4 and 5). The southern, spit portion of the site sits atop a gravel and sand spit fronting a large saltmarsh and mudflat complex that historically stretched across the entirety of the area immediately north of Oak Bay, prior to dredging of the ship canal between Port Townsend Bay and Oak Bay (Figure 6). The Port Townsend Ship Canal was dredged in approximately 1915 (Todd et al. 2006). Dredge spoils from creation of the approximately 15 ft deep channel (below mean lower low water [MLLW]) were placed on the former mudflat adjacent to the ship canal to make dry land north of the spit (Figures 1 and 6). The channel both breached the spit, which used to be continuous, and severely altered the former mudflat to become an upper intertidal lagoon, dry land, and deepwater channel (Glaster 1989, Todd et al. 2006). Table 23 from Todd et al. (2006) lists the approximate habitat area conversion between 1872 and 2000 (Table 1).

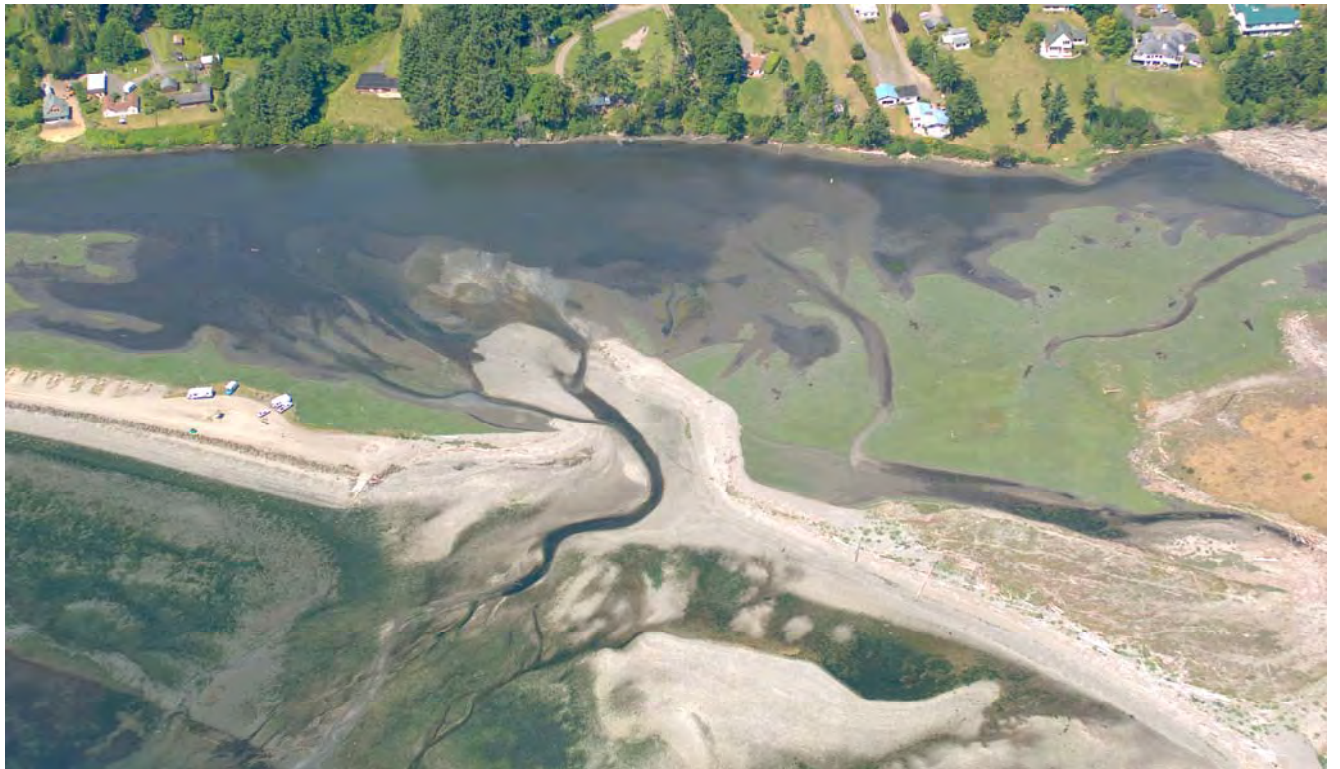
Figure 5. Oblique aerial photo looking northwest at Little Oak Bay Lagoon, taken 6/23/2006 for WA DOE.

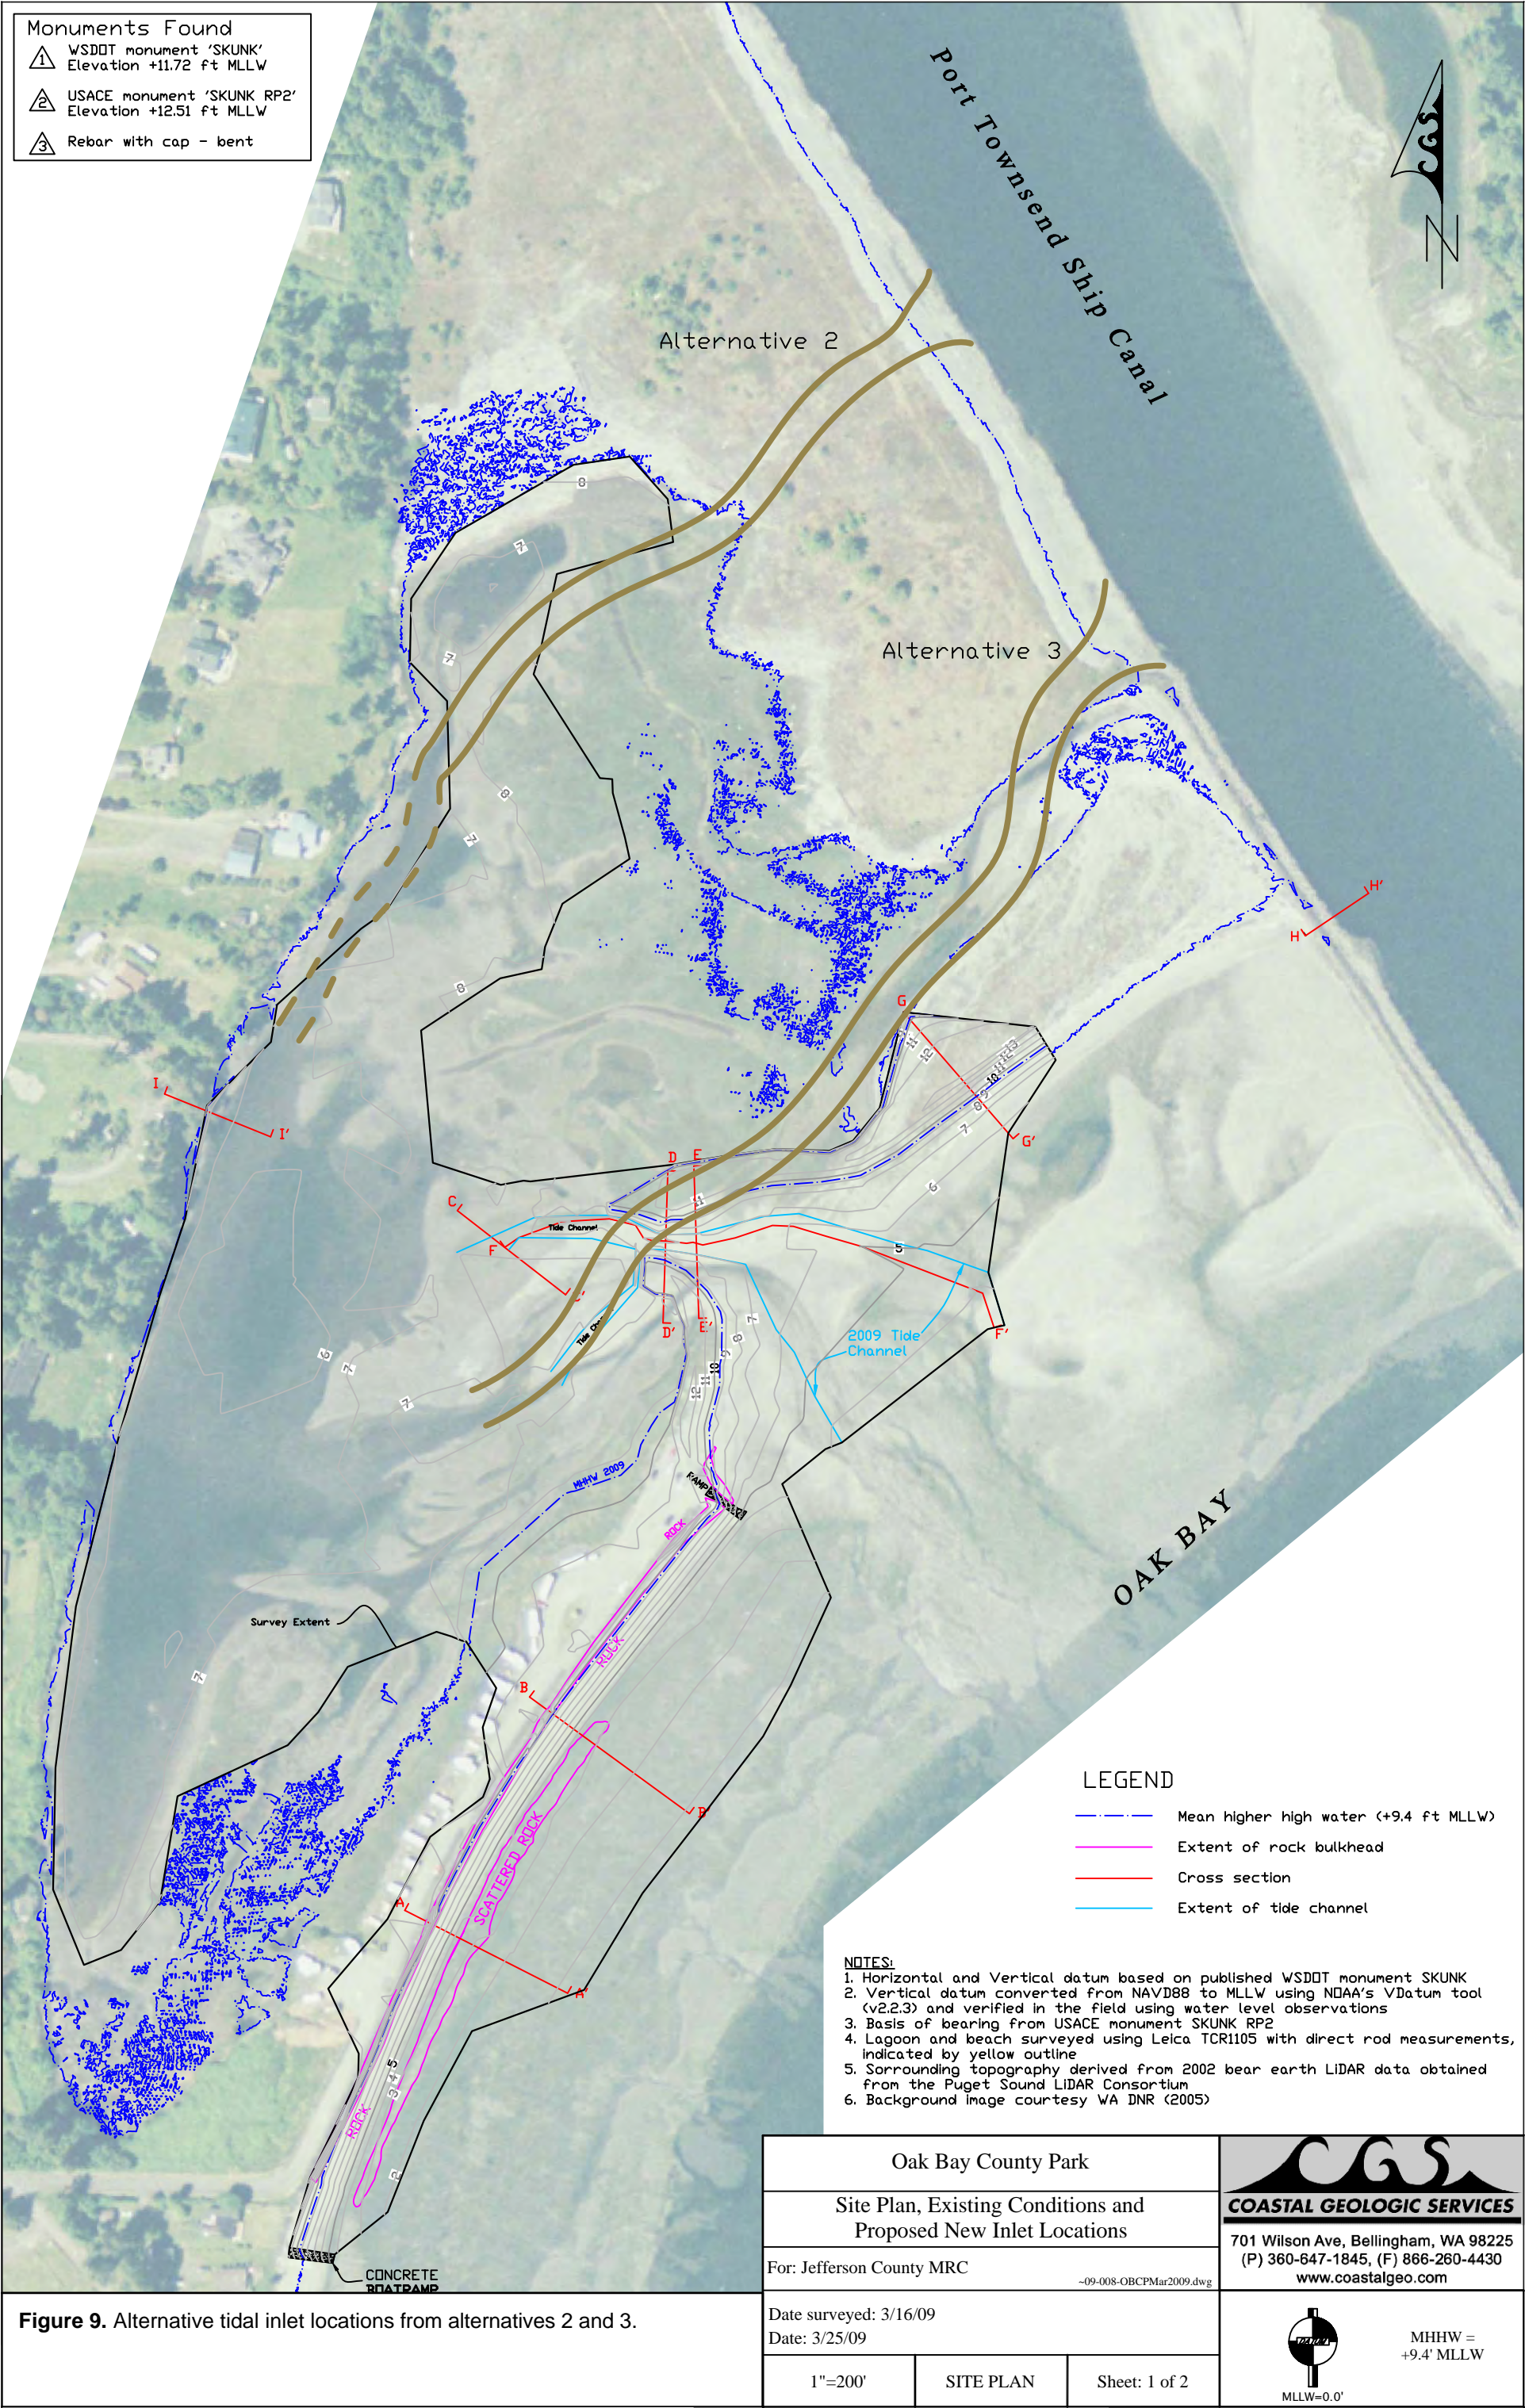
Figure 9. Alternative tidal inlet locations

Under both Alternatives 2 and 3, which would remove the revetment and boat ramp, close the present inlet and create a new inlet to the Port Townsend Ship Channel (Figure 9), the inlet would be more stable
